DENISON HYDRAULICS

VANE TROUBLESHOOTING GUIDE

1 - EN0721 - A 02 / 99 / 5000 / replaces SI - EN175 - A

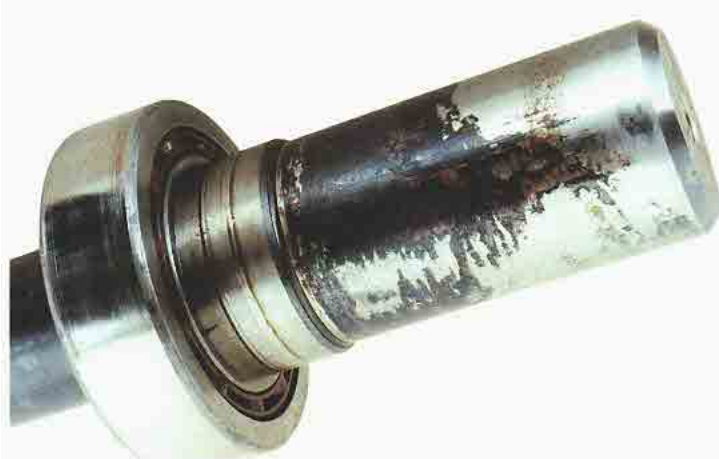
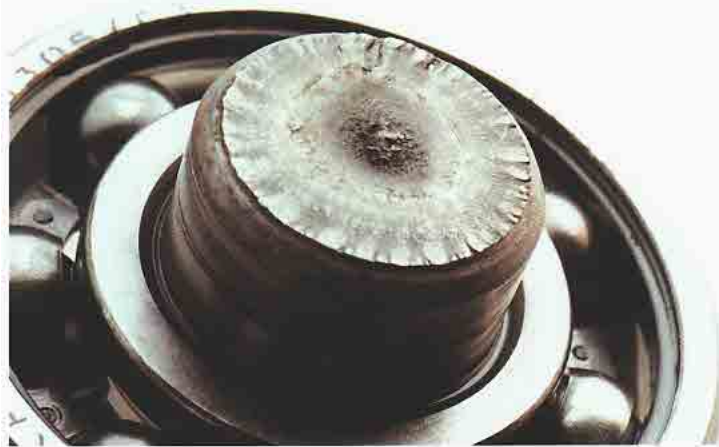
II-2-2-1

- Perpendicular, center, rotational bending fatigue rupture.

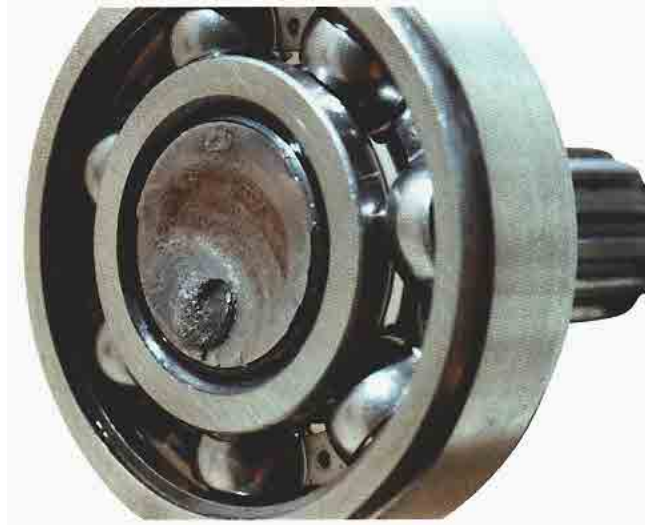
II-2-2-2 -
Perpendicular,
over-center rotational
bending fatigue rupture.

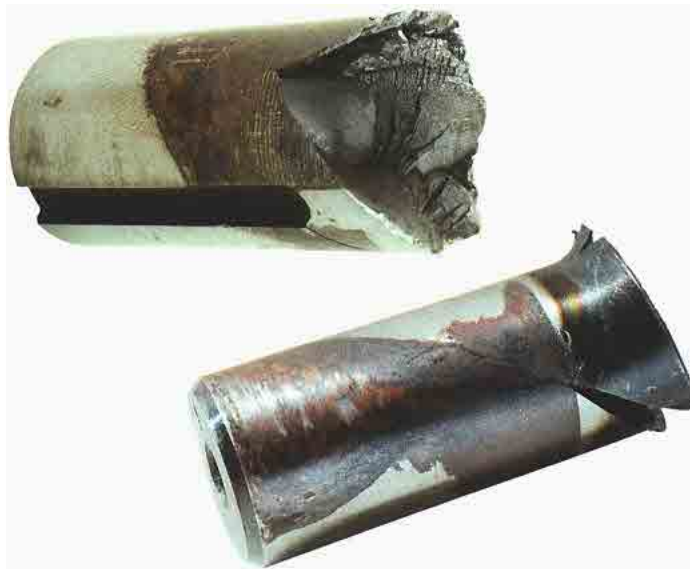
II-2-2-3 - Twisted tor-
sional rupture.

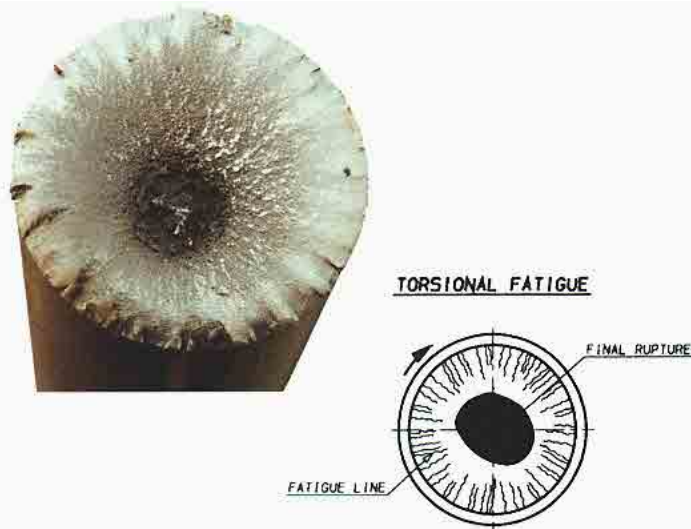
II-2-2-4

- Perpendicular, torsional fatigue rupture.

- Torsional fatigue with peak torque values
P 9, II-1-8

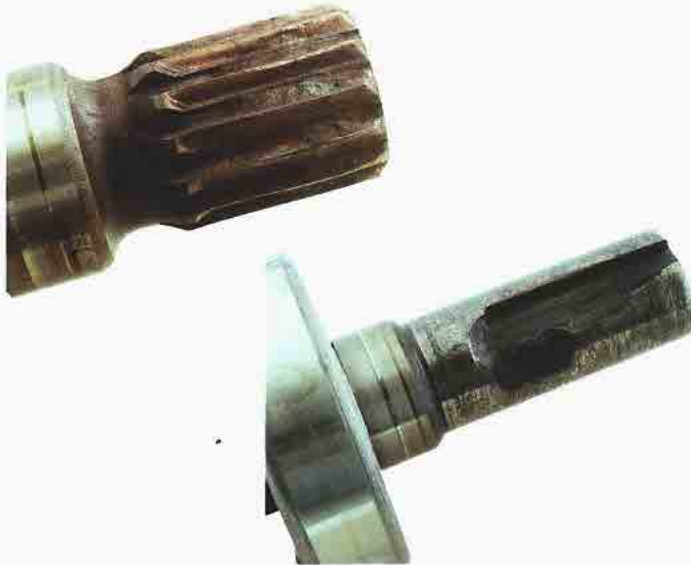
**II-2-3 - Shaft splines/
keyed shaft worn
out on total length.**

- Bad shaft / coupling connection
P 10, II-1-2-2
- Bad lubricant (Grease)
- Over torque values
P 9, II-1-8
- Highly cycled

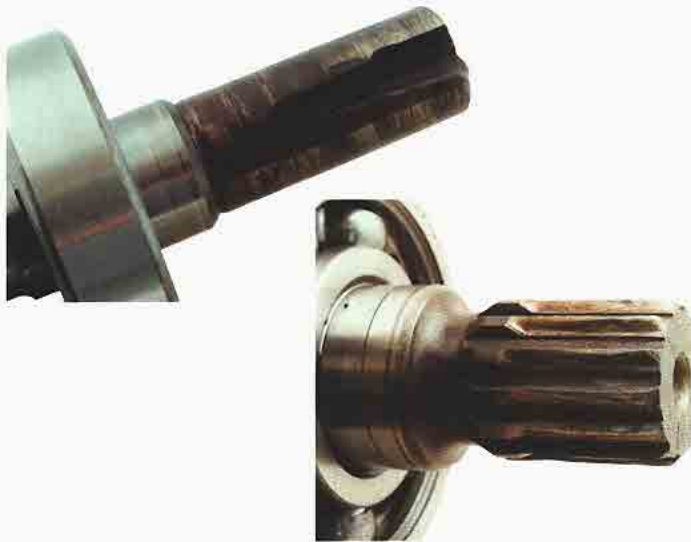
**II-2-4 - Shaft splines/
keyed shaft worn
out on part of the
length.**

- Over torque values
P 9, II-1-8
- Utilized key surface or splined surface too small
P 10, II-1-2-3

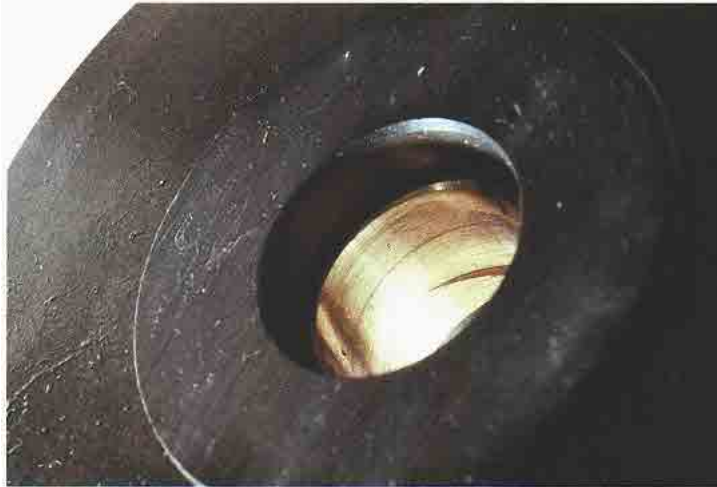
II-2-5-1 - Front or back bearing/bushing with heavy wear

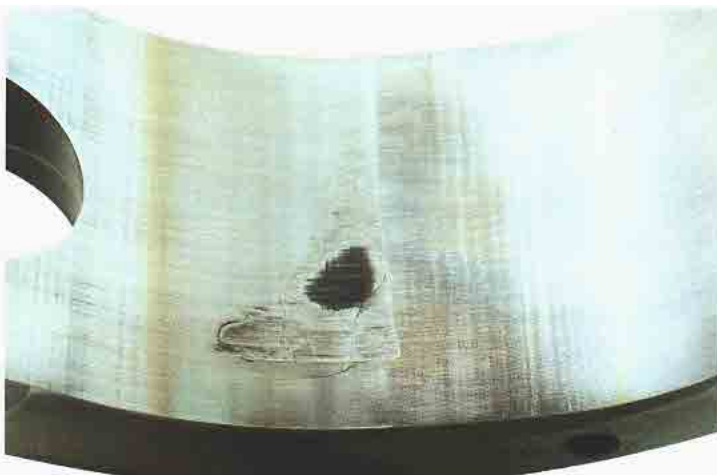
II-2-6 - Cam ring marked by the rotor on the smallest diameter. If the contact between the rotor and the cam ring is important, it will transform the hardness of the cam ring and create local tensions (cracks).

- Problems on shafts
P 7, 8, 9, II-1
- Bad shaft / coupling connection
P 9, 10, II-1-2

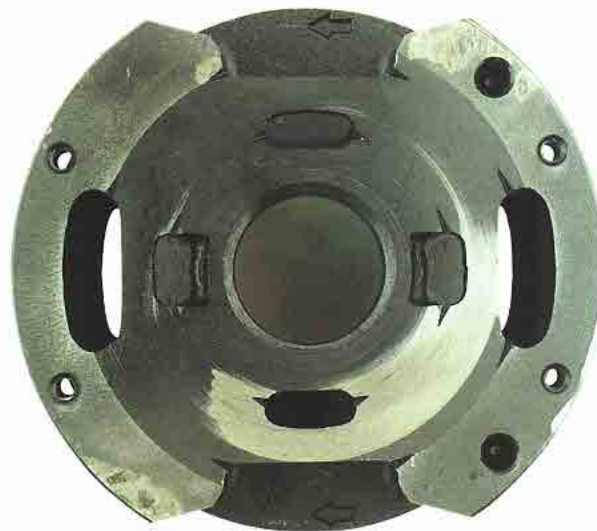
Dissymmetrical
wear on the side
plates

- Problems on shafts
P 7, 8, 9, II-1
- Bad shaft / coupling connection
P 9, 10, II-2

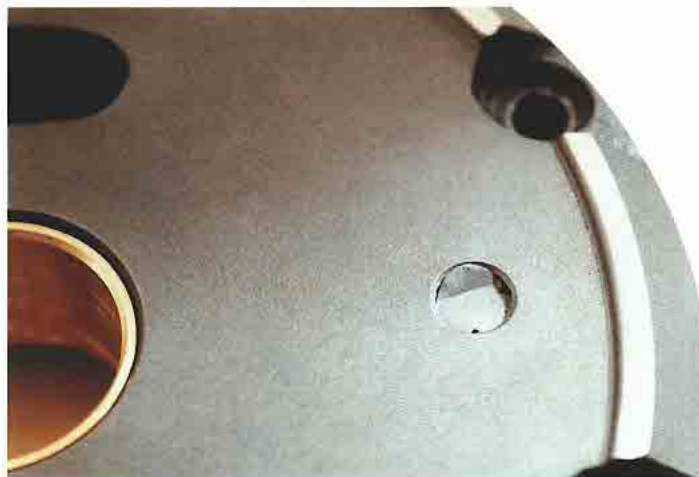
II-2-9 - Dowel pin broken

- Over torque limits
P 9, II-1-8
- Cartridge not properly mounted
in the housing P 10, II-1-3

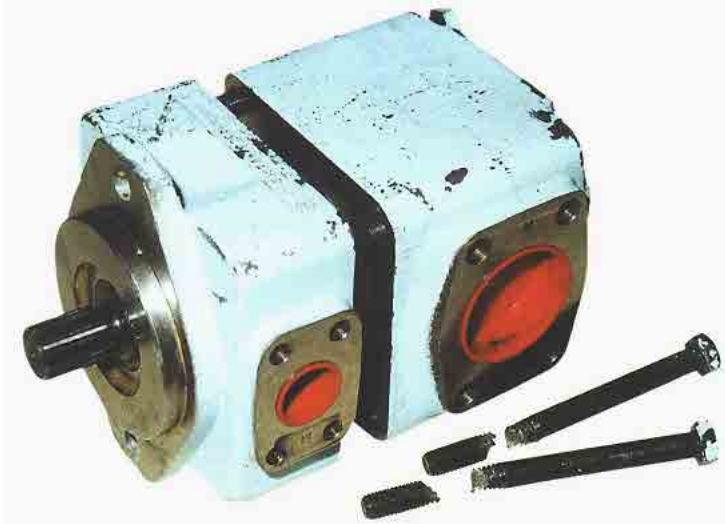
II-2-11 - Broken screws

- Loose pump fasteners
P 11, II-1-6

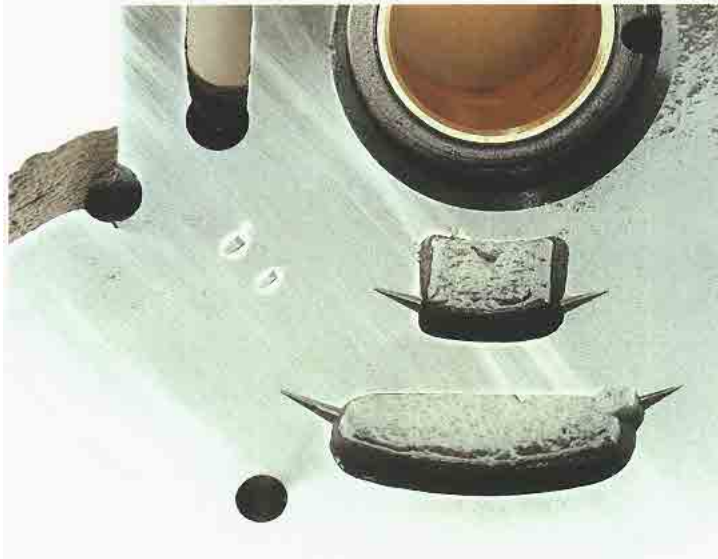
II-2-12 - Parallel marks on the port plate (vane marks)

- Cartridge not properly assembled P 11, II-1-4

- Tilted vanes marked the port plate but the pump did not rotate.

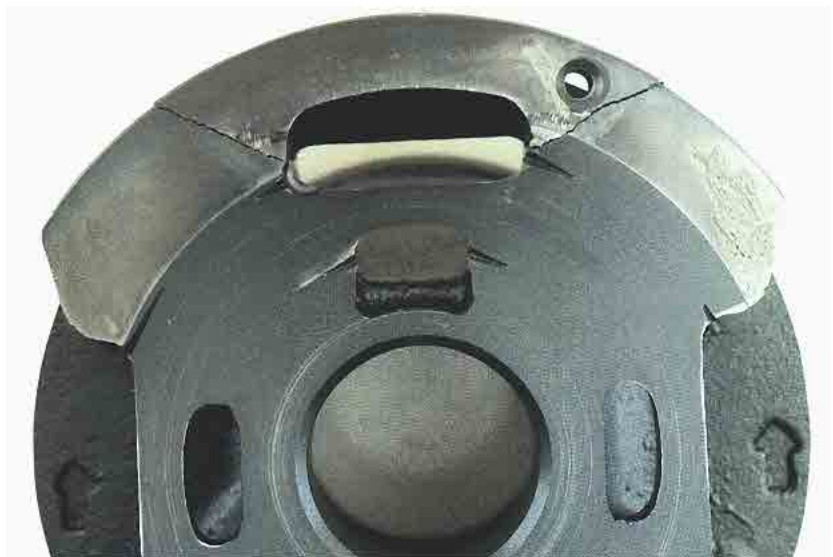
II-3-3-1 - Cracks or rupture of the pressure plate

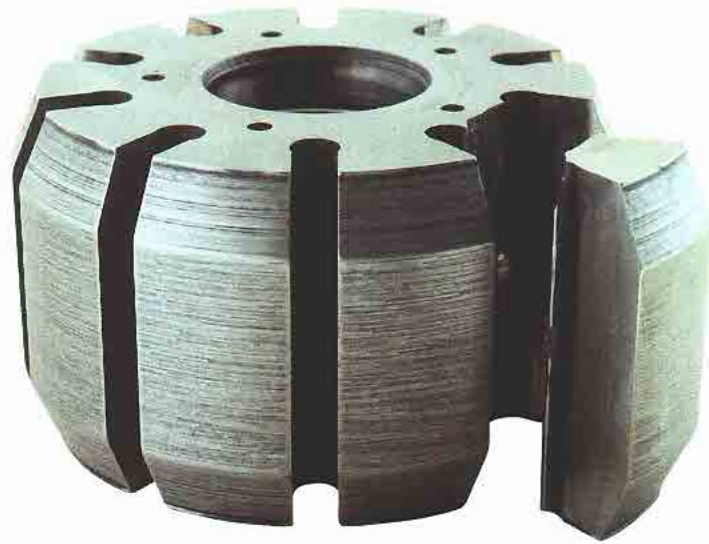
II-3-3-2 - Cracks or rupture of the rotor

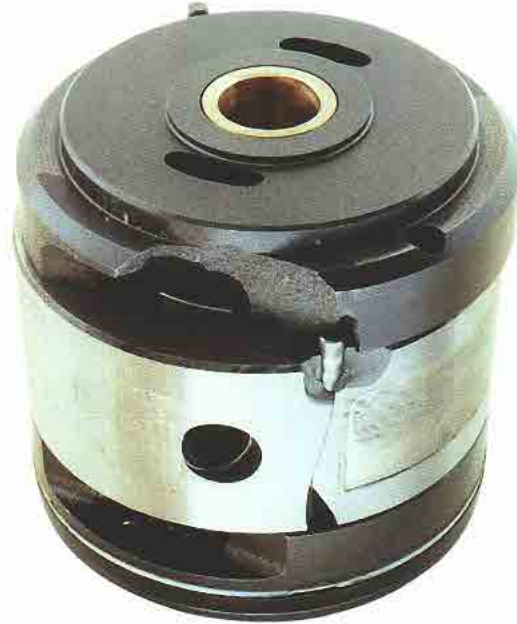
II-3-3-3 - Cam ring cracked

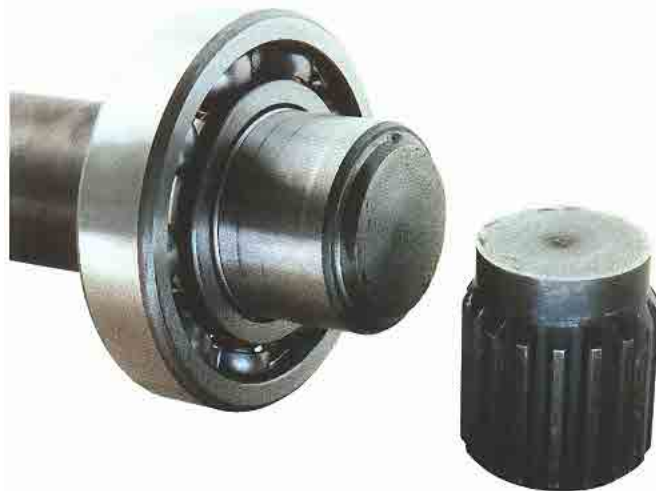
II-3-3-4 - Shaft broken: perpendicular "clean cut"

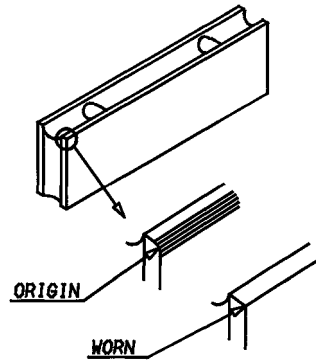
II-3-5-1 - Vanes

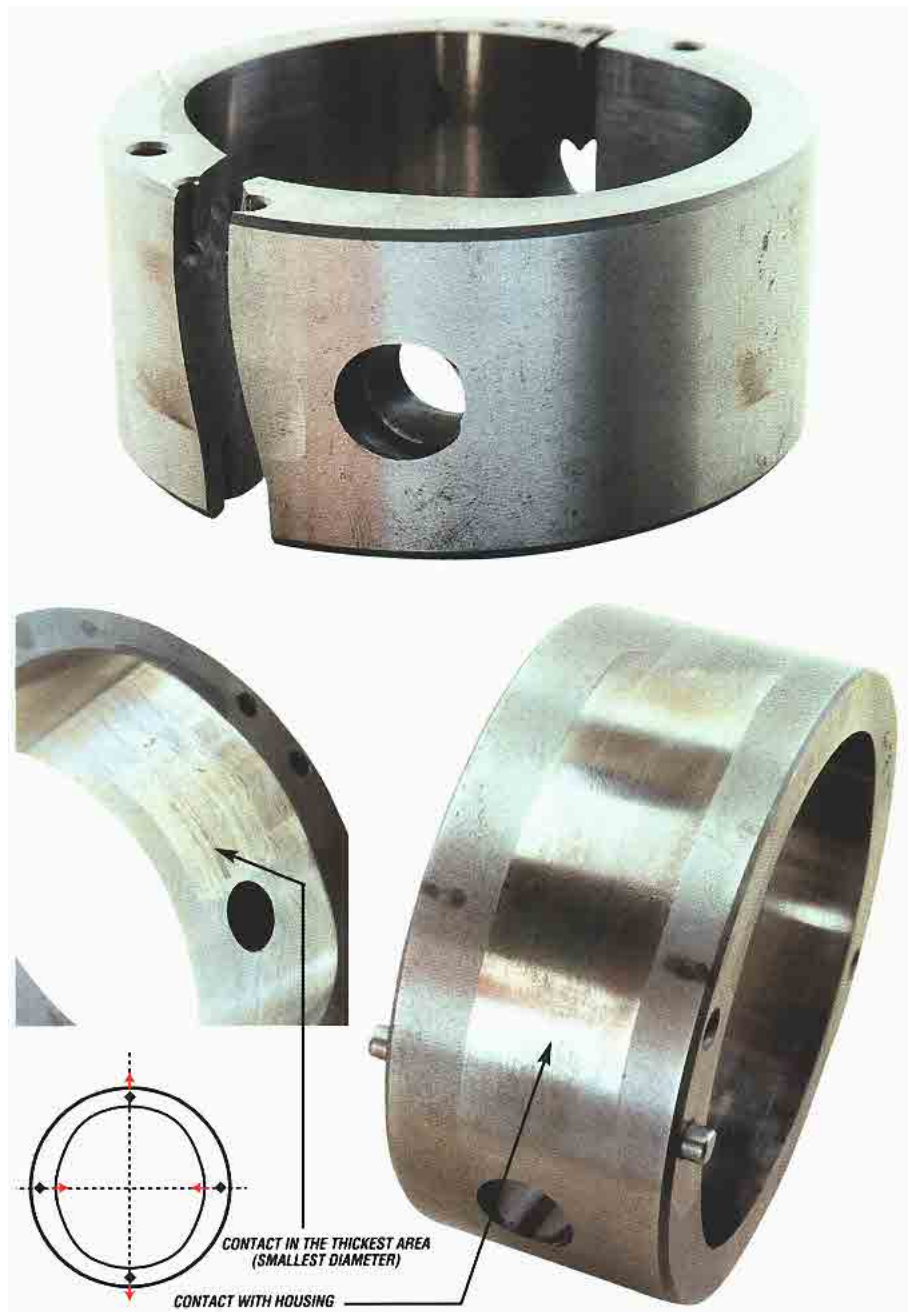
II-3-5-2 - Cam ring:

-rupture/cracks

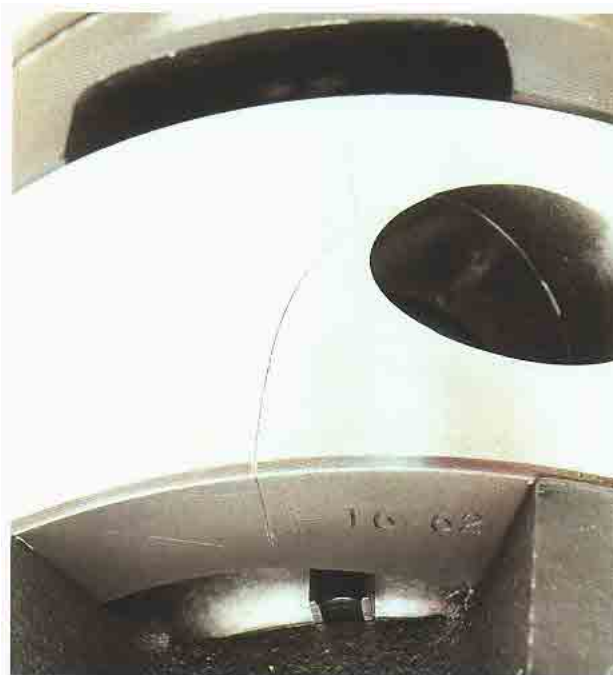
II-3-7-1 - Cam ring fatigue rupture

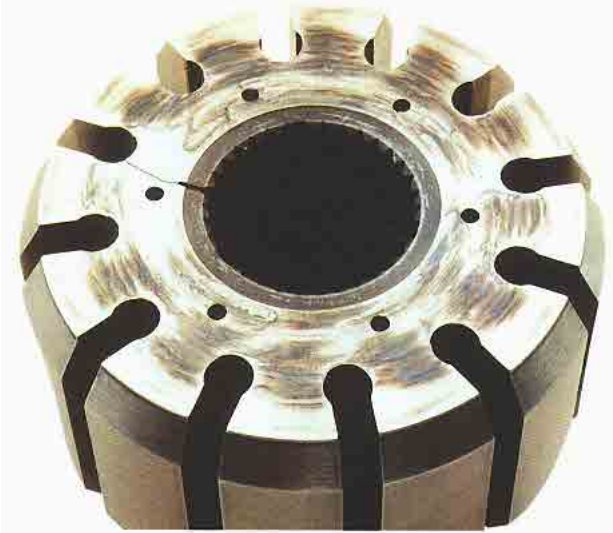
II-3-7-2 - Rotor/side plates seizure: This is due to a very strong cavitation when the pressure decrease is dramatic. The sudden flow required is so important that the instant local velocity rises and creates the cavitation.

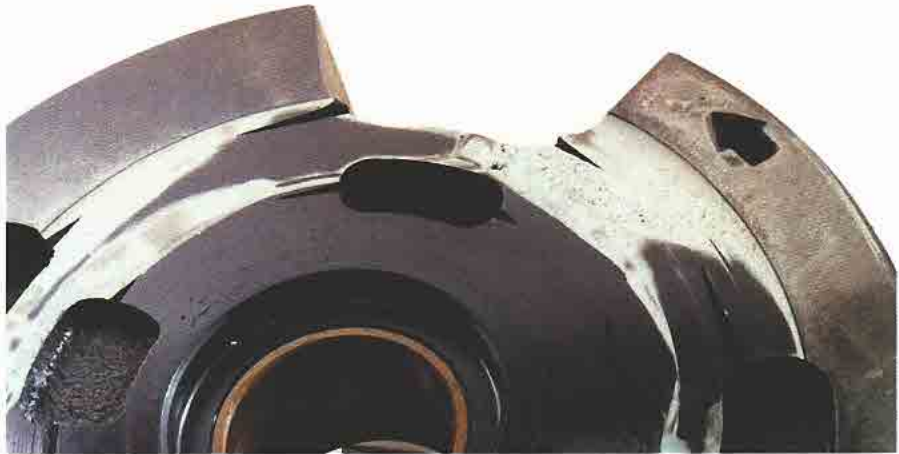
II-4-2-2-2 - If under very severe aeration, this groove can mark deeply the port plates from the suction area to the outlet area. The width of the groove is then the width of the vane.

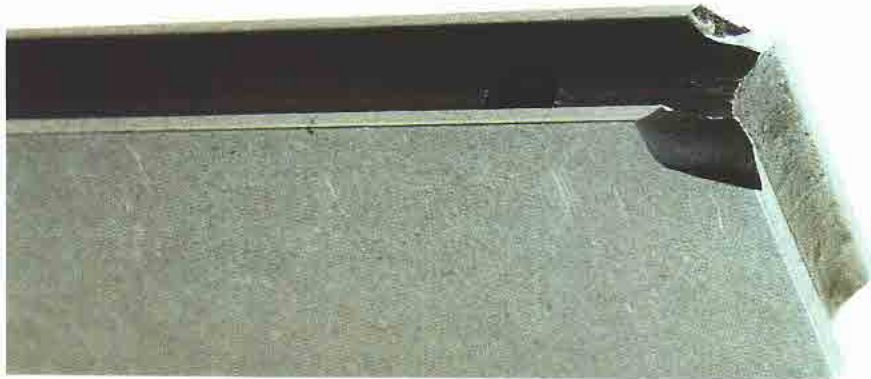
II-4-2-2-3 - In very heavy air conditions, the vane is so unbalanced that it can even sometimes break (itself).

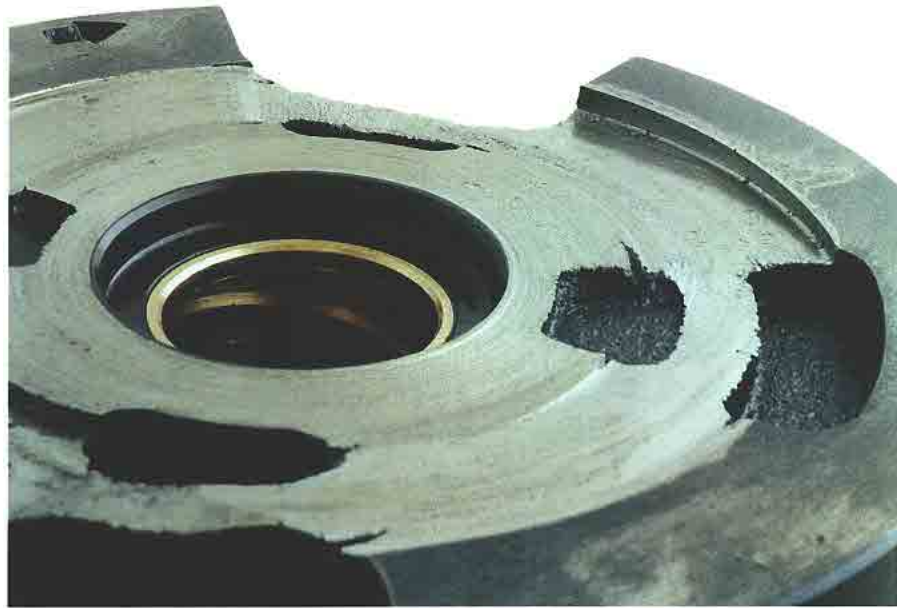
II-4-2-2-4 - Noisy (continuation)

Before obtaining such a disastrous wear, the vanes being so unsteady will make a lot of noise, the flow will not be the one required and/or the

pressure level will not be obtained. The physical aspect of the oil will be "milky" on the surface as the oil and the air create a foam.

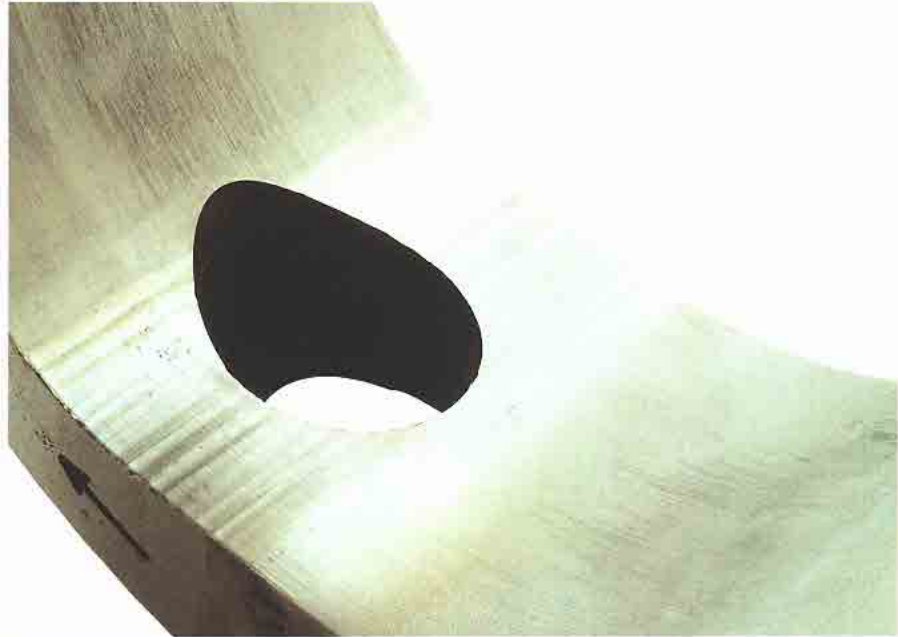
II-4-2-4-2 - Ripples on the cam ring: the vanes are hydrostatically balanced to avoid excessive loads on the vane lips. Under suction cycle, the pin compensates the out of balance load due to the cam profile. When the depression is over the design limits, the vane bounces, creating ripples on the cam ring profile. The depth of these marks is proportional to the strength of the depression.

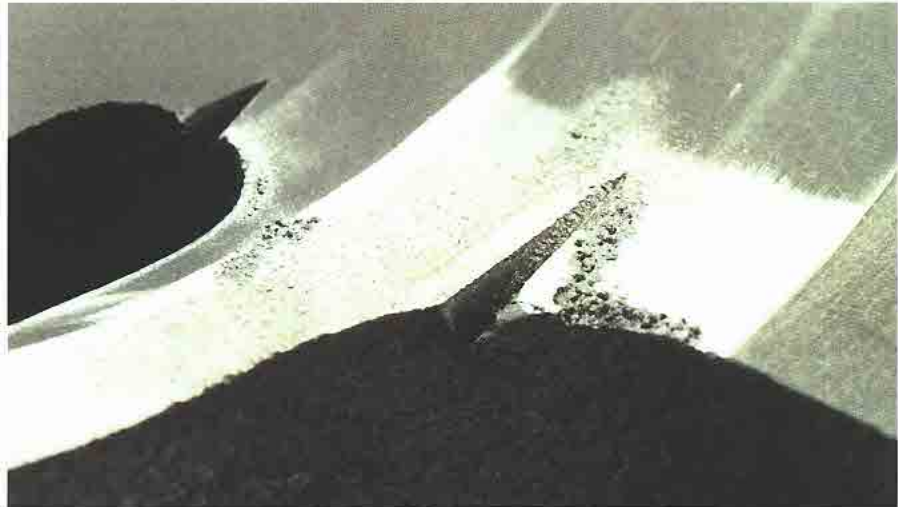
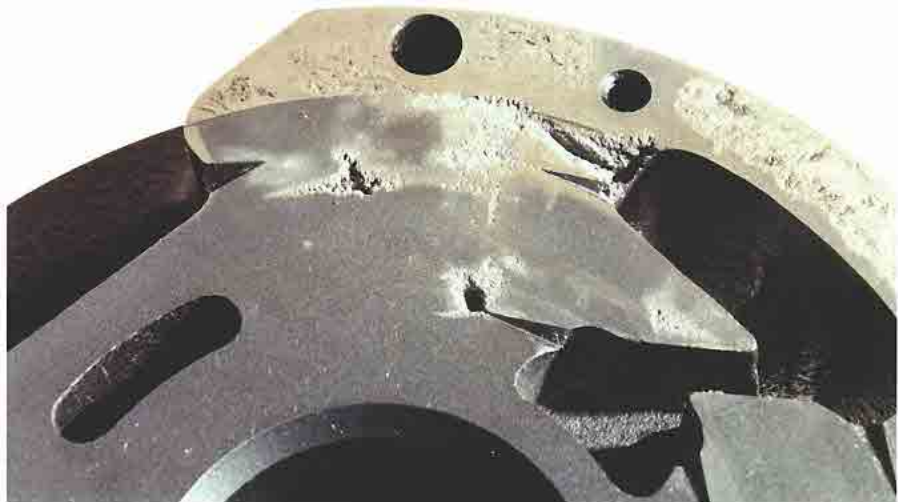
II-4-2-4-3 - Craters: these erosion craters are sometimes difficult to observe as the pump may have already seized. These craters come from erosion, caused either by an explosion/implosion, either by depressurisation.

When the fluid trapped between the two vanes is sucked in with a certain percentage of air in suspension, an explosion can occur. When this trapped volume is compressed, these air bubbles explode and create craters in the side plates in the area between the suction port and the pressure port, around the pressure bleed slots.

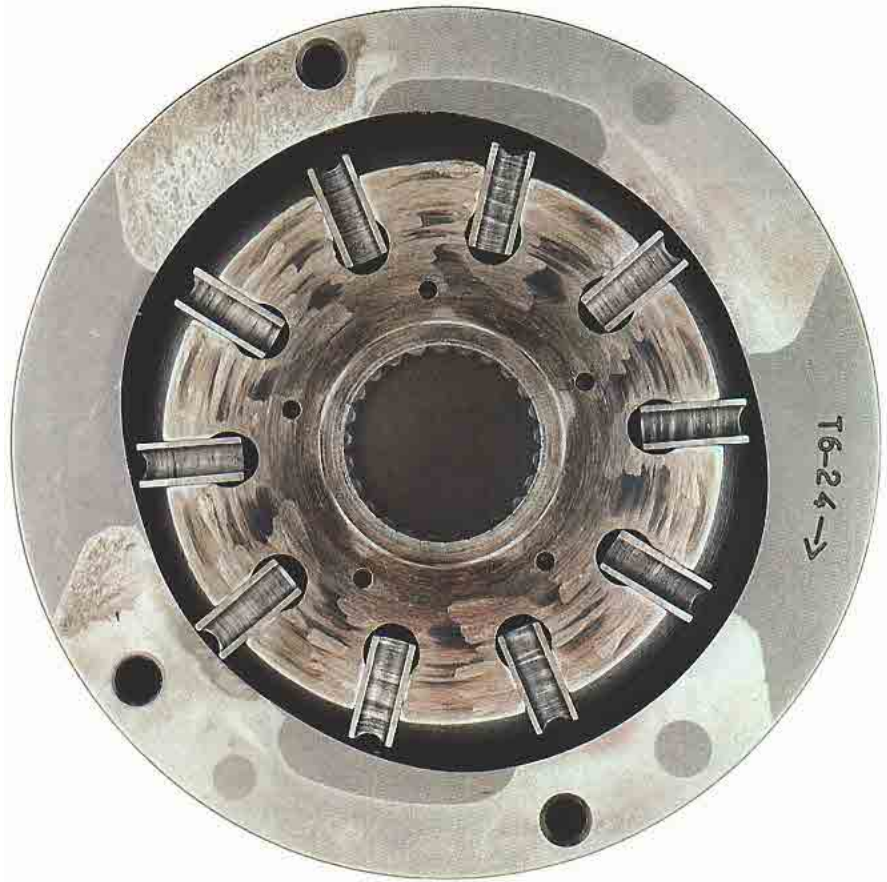
Due to a lack of fluid, the vacuum generated, when really severe, will suck the oil on the side of the pump (between the rotor and the side plates). This will have the effect of breaking the film of oil that lubricates these surfaces. The surfaces will then heat-up and this local over-heat will modify the standard lubricity into a dry friction. The result is a seizure between the rotor and the side plates. (This heavy contamination coming from the digging of craters, the particles can also badly lubricate the pump and lead to the seizure.)

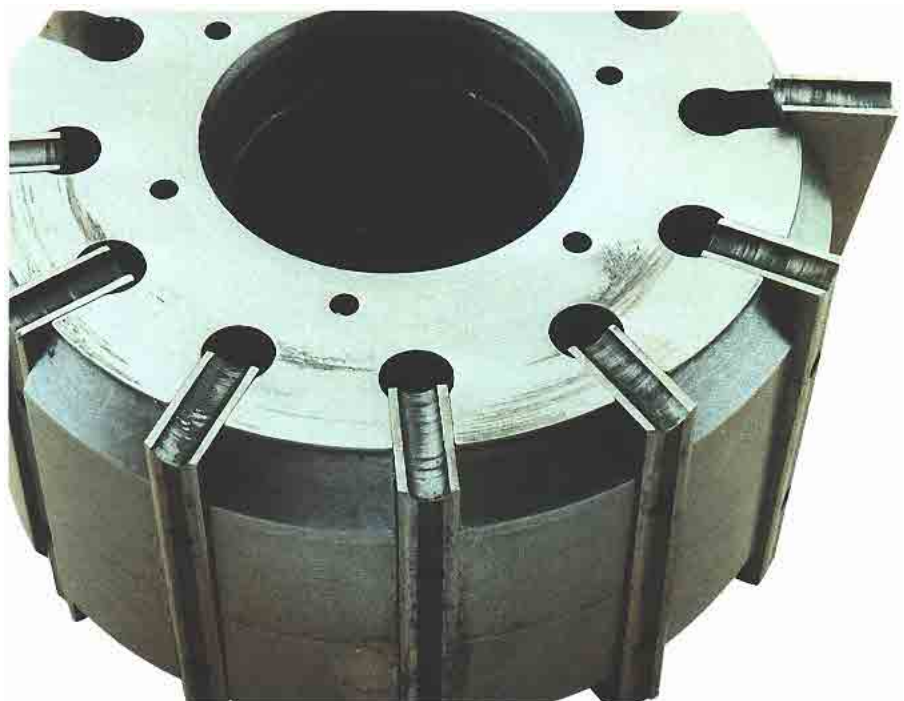
- The vane lips edges. The particles in the fluid will have a grinding effect between the top of the lip and the cam ring profile. When the contaminant is too big or too stiff, the vane lip edges can break.

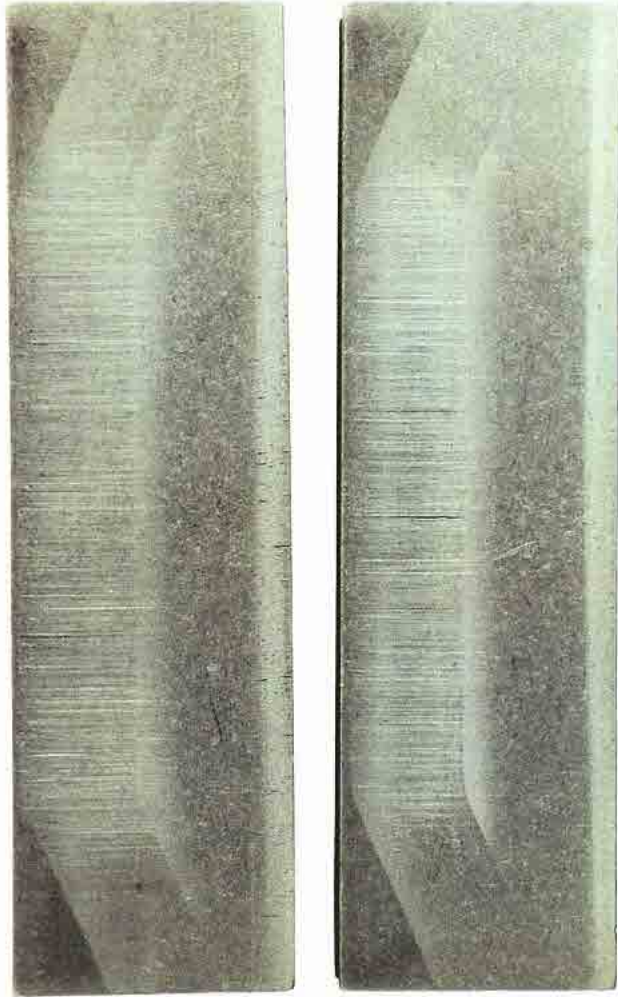
- The vane surface. The film of oil between the vanes and the rotor being contaminated, there will be a rubbing effect in this area. These rubbing marks (pol-
lution marks) will be vertical and of the height of the vanes' translation (displacement).

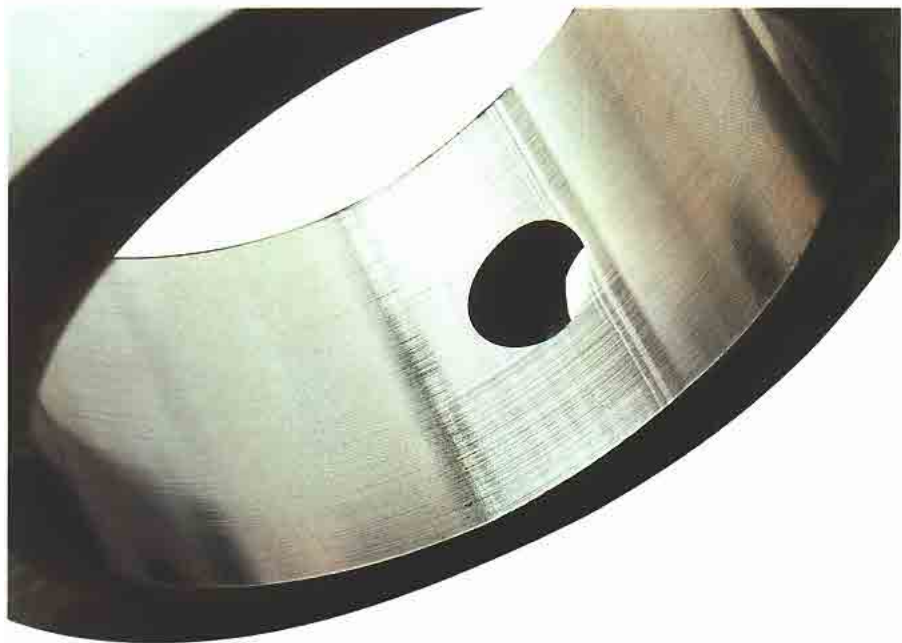
- Between the vane lip and the cam ring, the film of oil is contaminated. This will wear the inner surface of the cam ring.

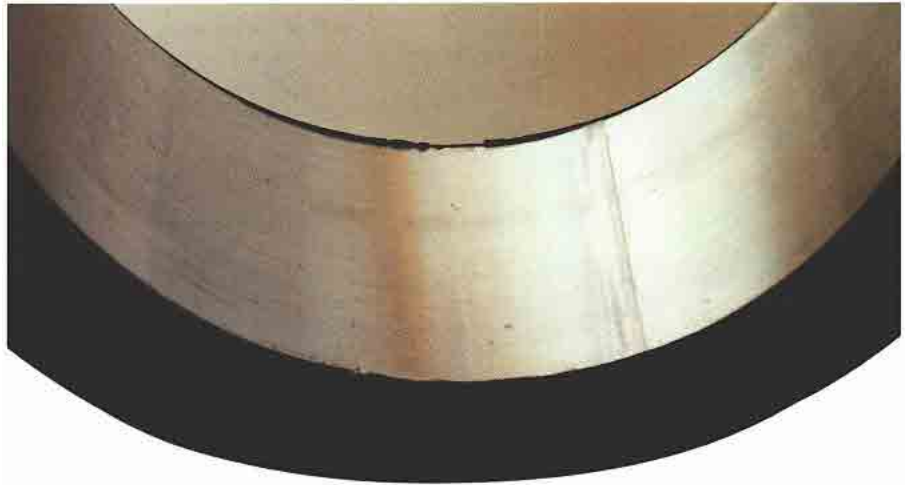
- On the edge of the cam ring contour, (with a slight chamfer when new), you will find a sharp angle (edge). If the wear is heavy, the cam ring can have little burrs in this area.

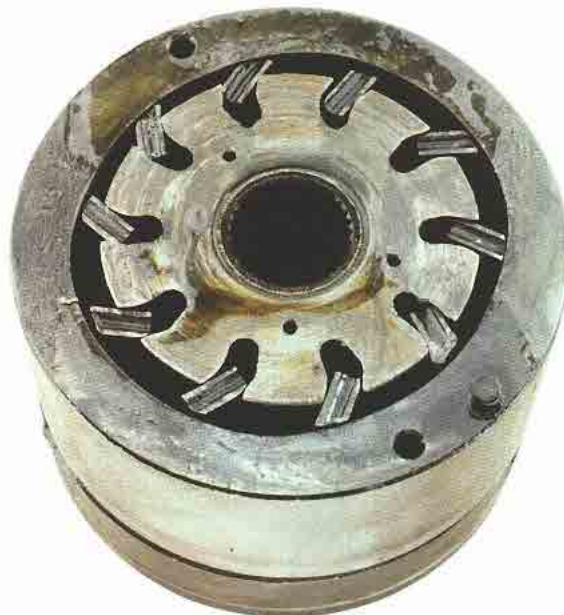
In the rotors' slots, the rubbing wear between the slots and the vanes will also lead to vertical pollution marks. (P 32 II-4-4-2 b)

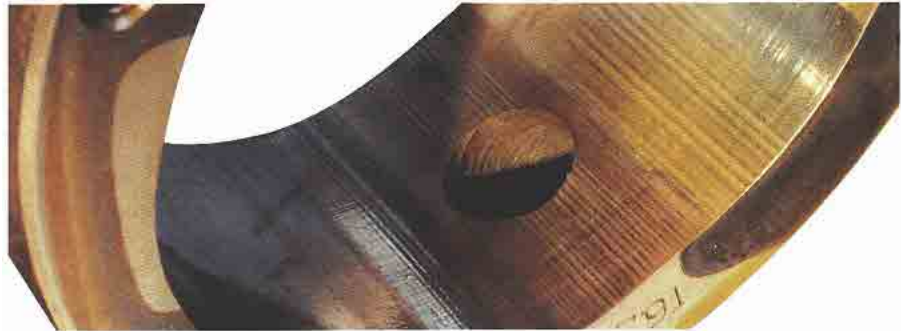
II-4-6-3 - The fluid compressibility will fluctuate and therefore destabilize the vanes. This will be seen on the cam ring surface full of ripples and on the sharp vane lips edges. In this case, the noise level will be high and the flow & pressure capabilities deteriorated.

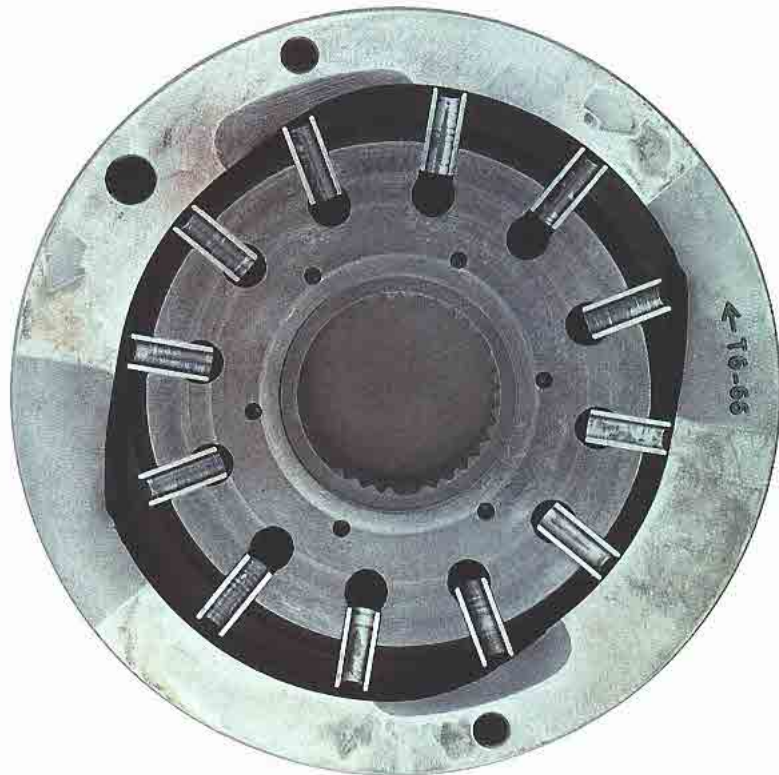
II-4-6-4 - Due to these fluid transformations, the mechanical consequences go from performance being deteriorated to the destruction of the pump if the local temperatures are extreme (Here, phosphate oil additive deposit).

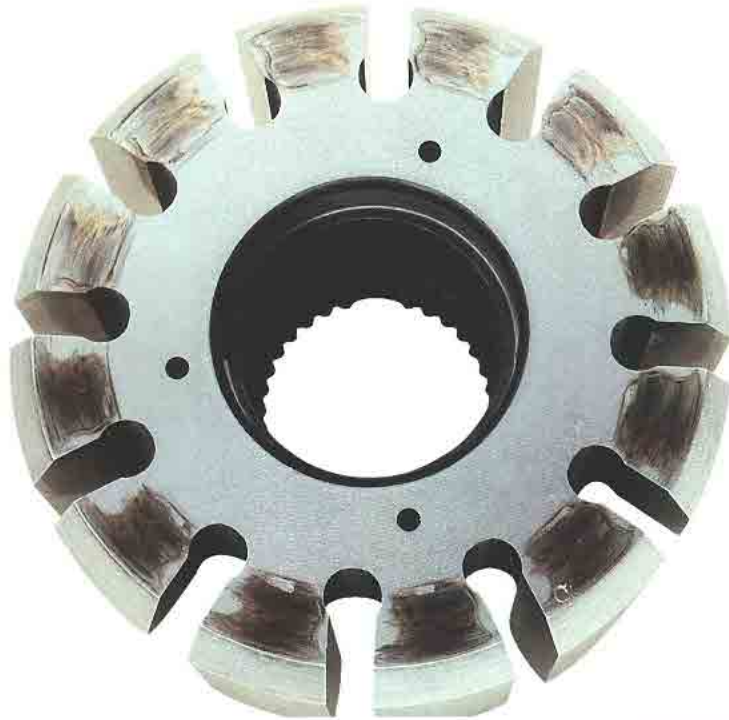
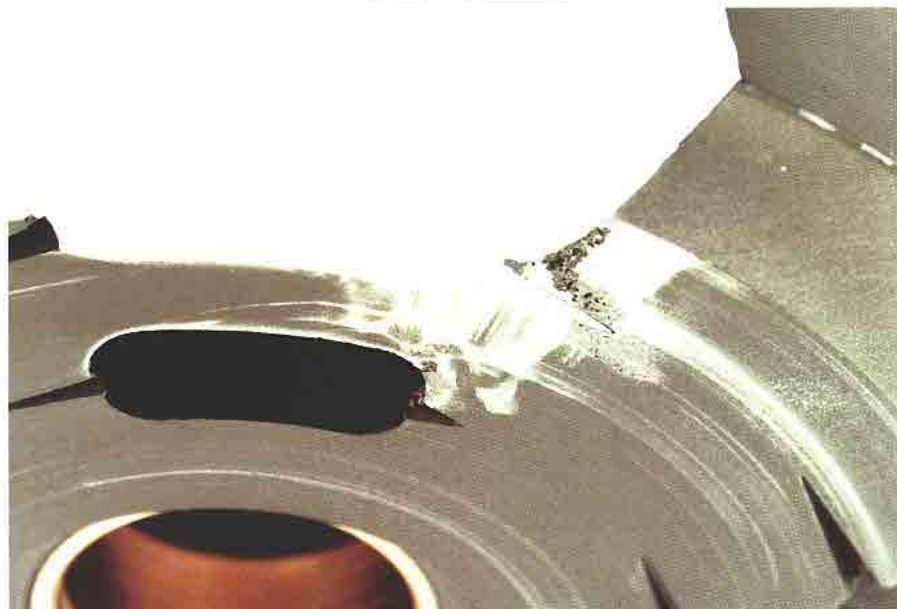
- Erosion on the port plates.

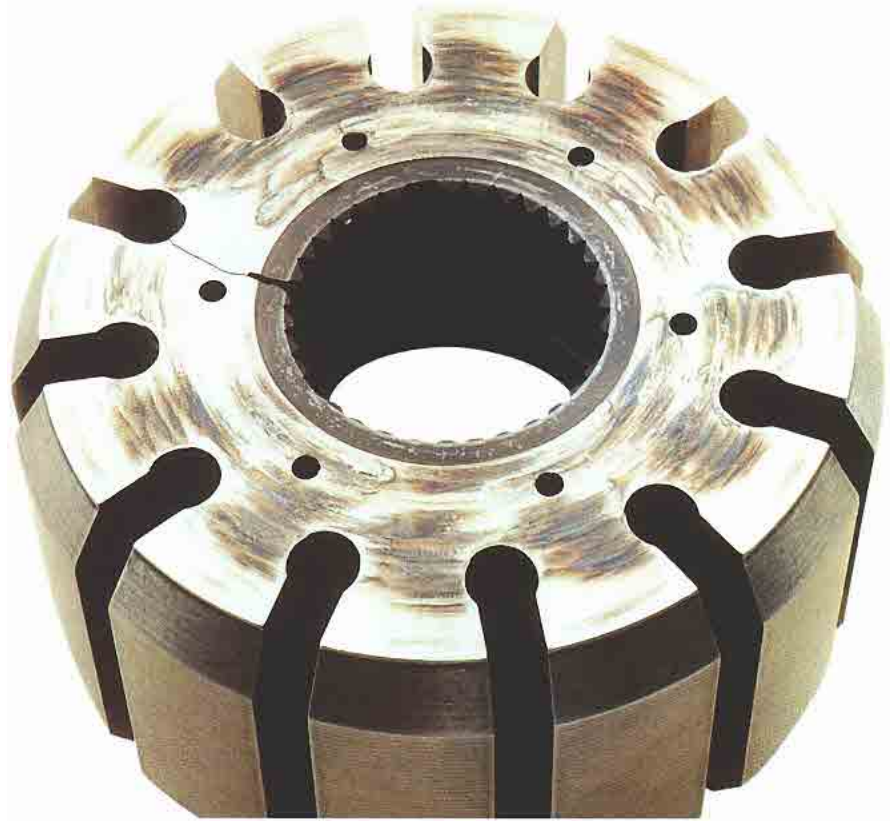
- Scars on the side plates & rotor due to a bad lubricity.

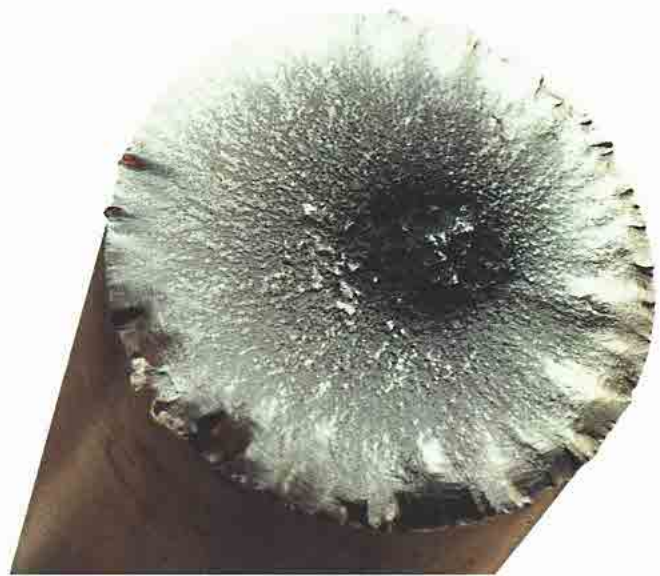
Front shaft rupture

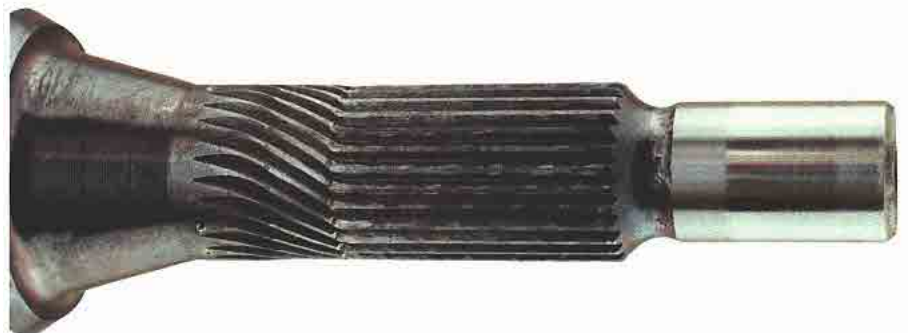
Internal splines distortion

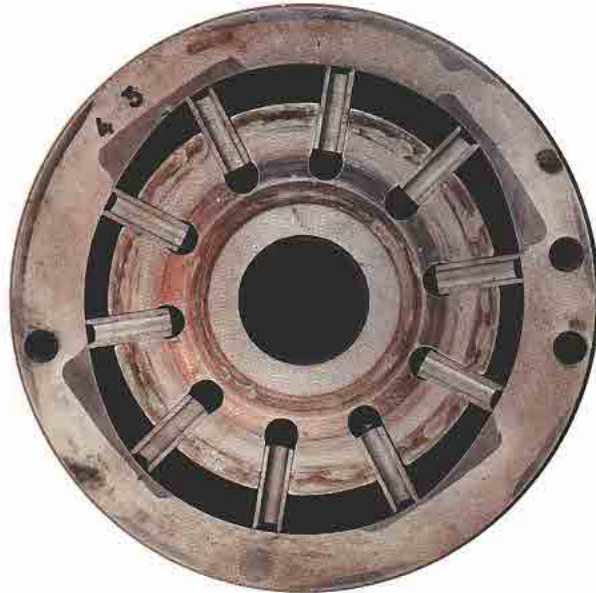
or air intake = incorrect rear cover lubrication. Possible seizure between the rotor and the rear cover.

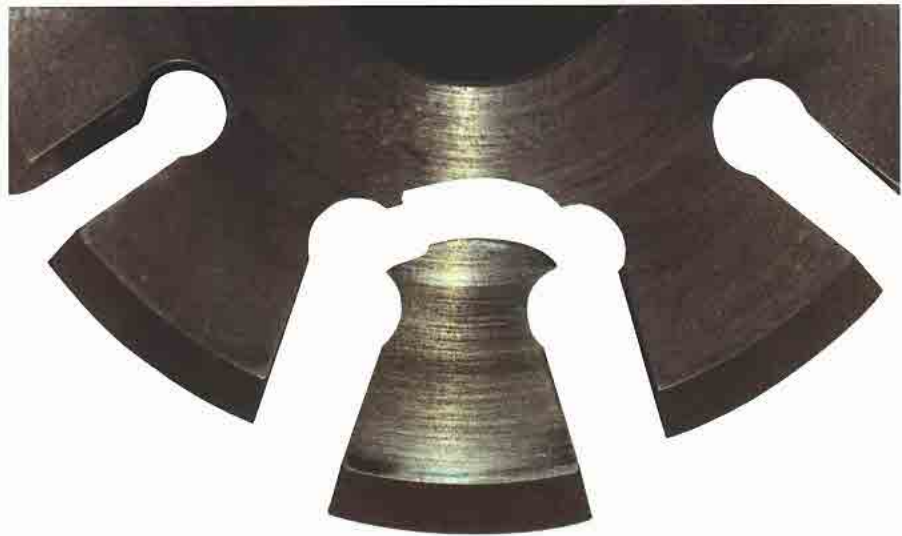
Rotor rupture

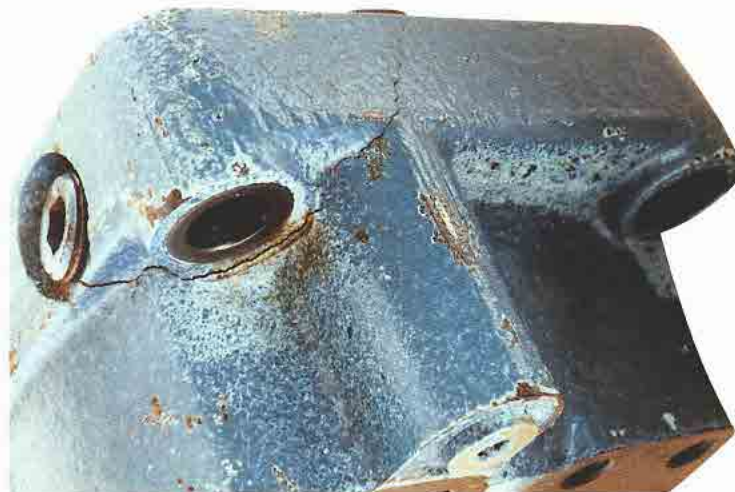
Port block cracked

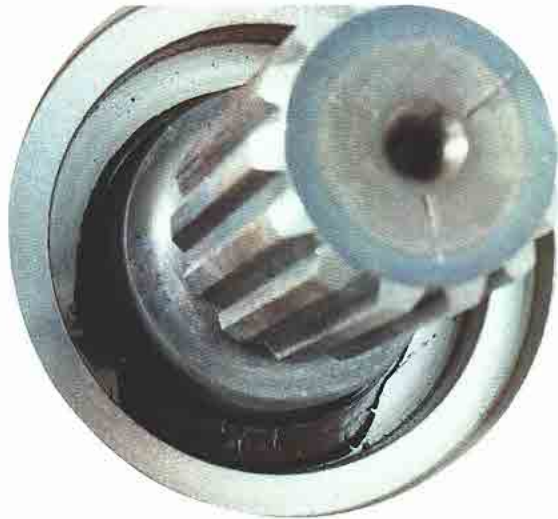
shaft seal blow off (extruded).

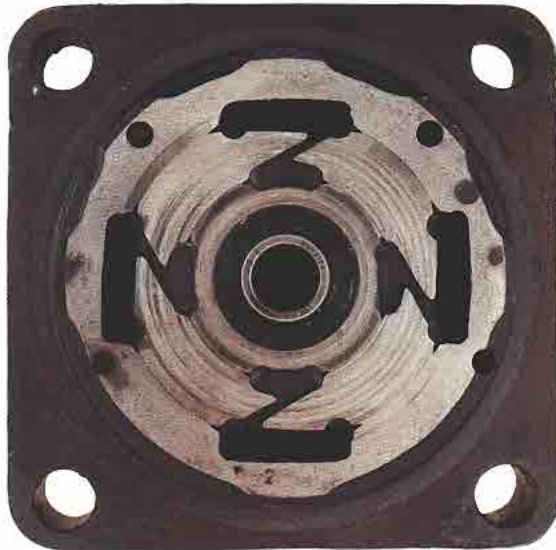
III-5- Excess of Air in the fluid: coming from the system, coming from an air intake between the pump and the motor or even coming from the front shaft seal.

- Possible seizure between the rotor and the rear cover.
- Possible heavy wear on the port plates.

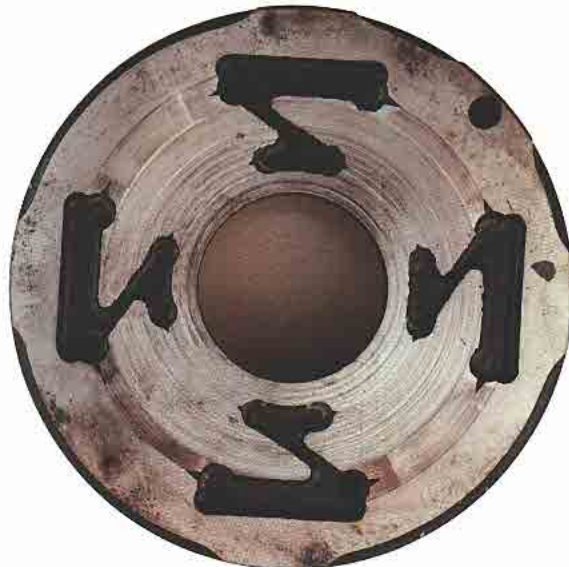
III-6-Cavitation: the speed of the motor is higher than the flow coming to the motor. Heavy cavitation will lead to seizure.

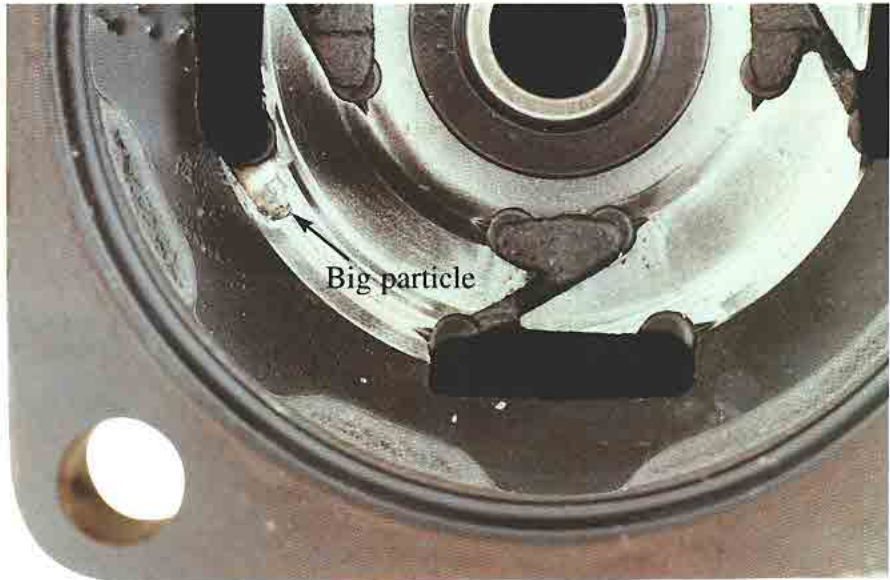
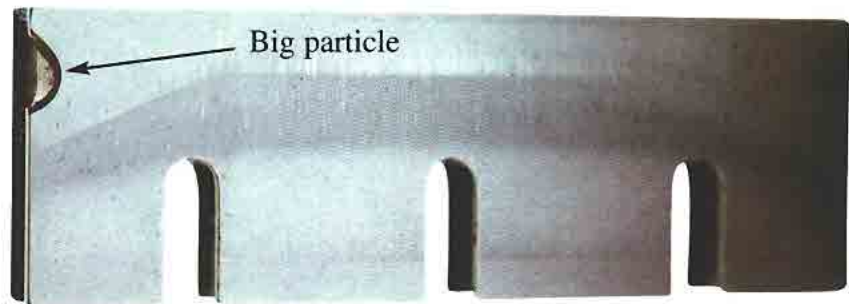
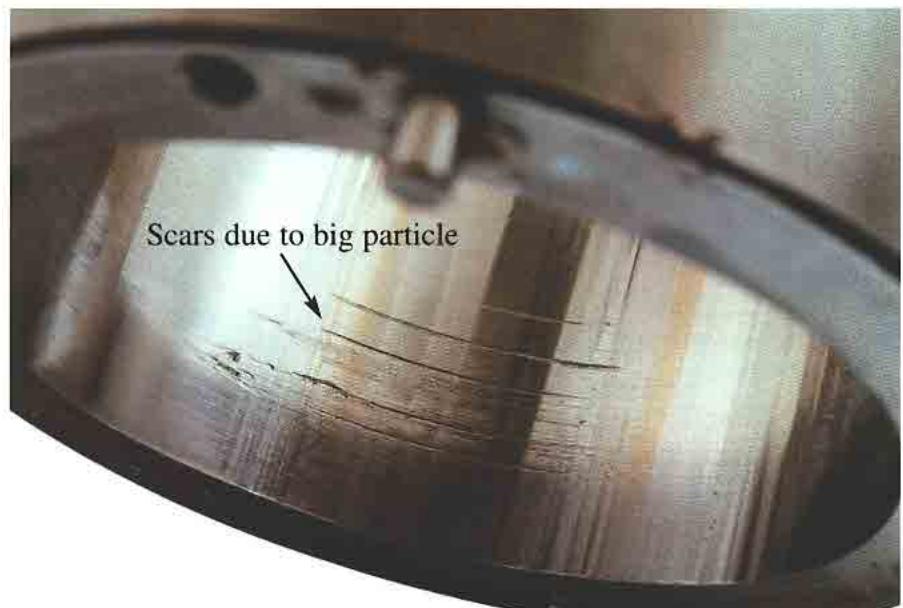
- In the rotor slots
 - Grinding on both sides of the slots.
 - Traces of the "spring areas" of the vanes digging in.
- On the side of the rotor / port plates.
- On the vanes
 - One big particle (welding ball) and small vertical scars.
- In the came ring
 - (Scars due to big particles).
