DENISON HYDRAULICS

VANE TROUBLESHOOTING GUIDE

1 - EN0721 - A 02 / 99 / 5000 / replaces SI - EN175 - A

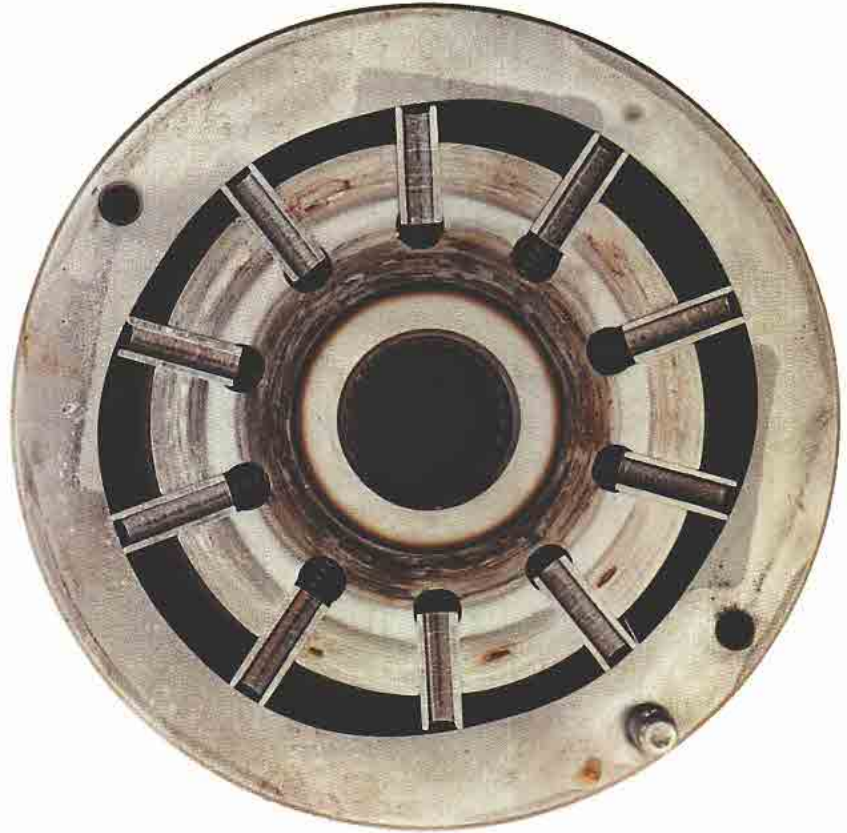
III-8- Too low viscosity:

If the temperature rises and the fluid becomes very "liquid", the film of oil required to lubricate the components is going to be too thin. This can lead to micro-seizures and to a total seizure if this film of oil is minor.
