DENISON HYDRAULICS

VANE TROUBLESHOOTING GUIDE

1 - EN0721 - A 02 / 99 / 5000 / replaces SI - EN175 - A

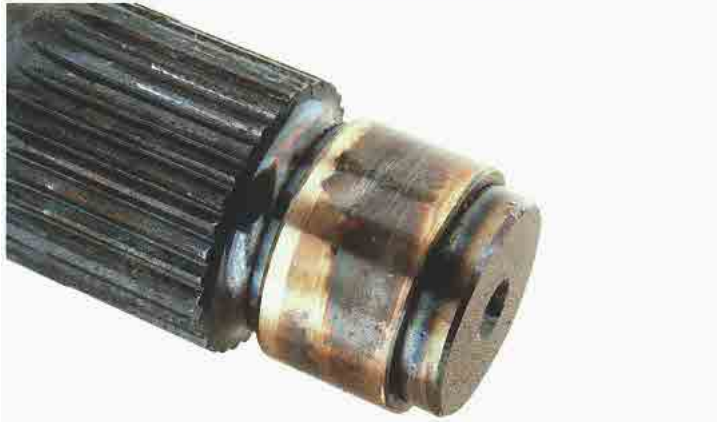
II-2-5-2 - Bushing "welded" on the shaft

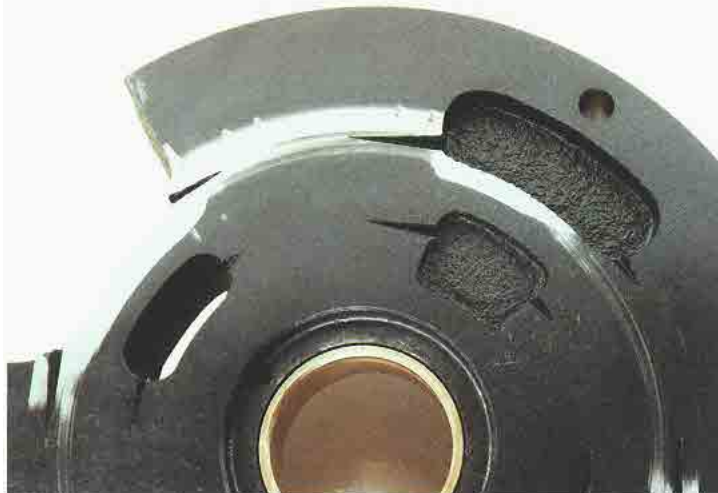
- Tilted vanes marked the port plate but the pump did not rotate.

- Tilted vanes but the pump did rotate. The result is scars on the port plate.

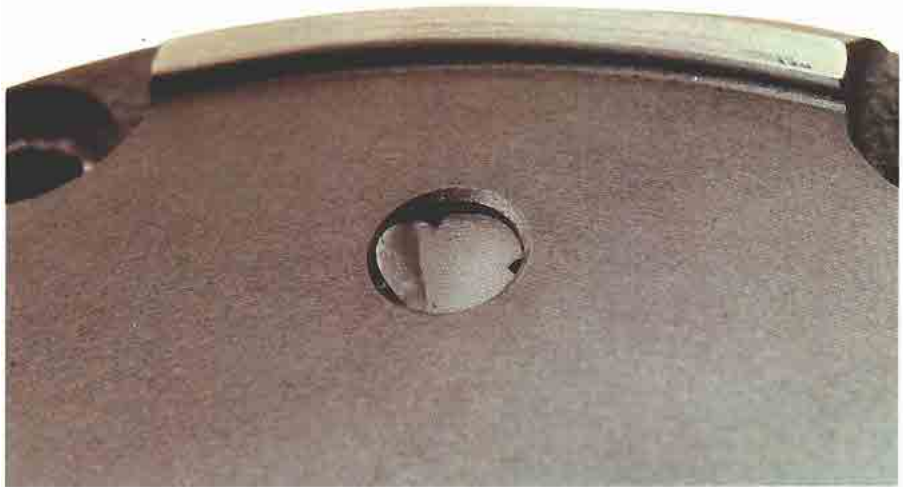
II-3-3-5 - Dowel pin cut in two

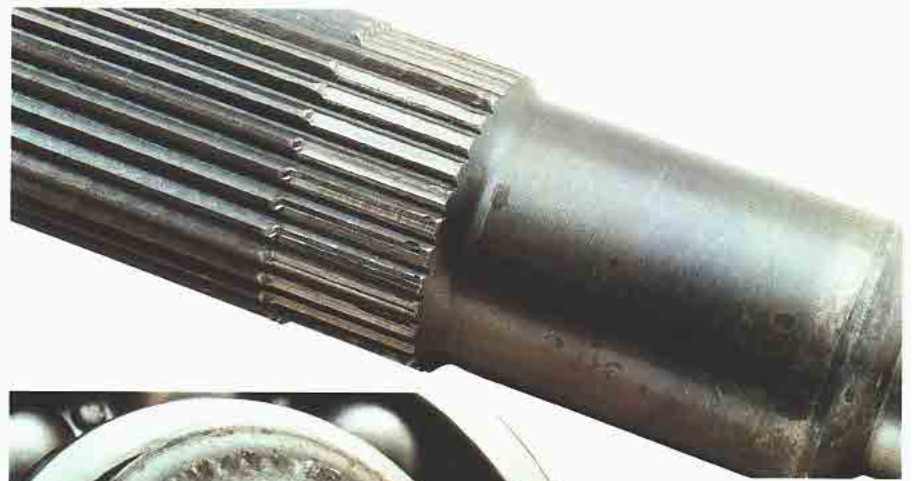
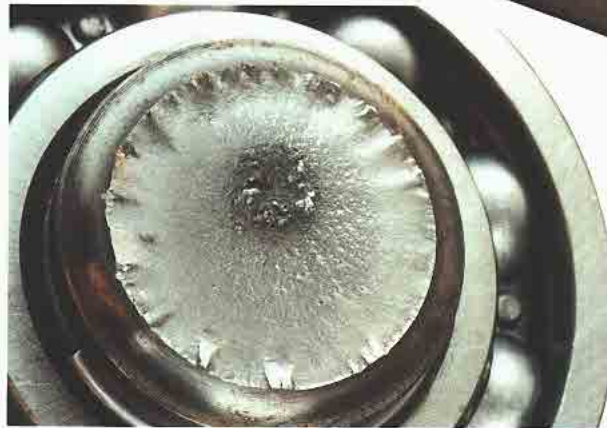
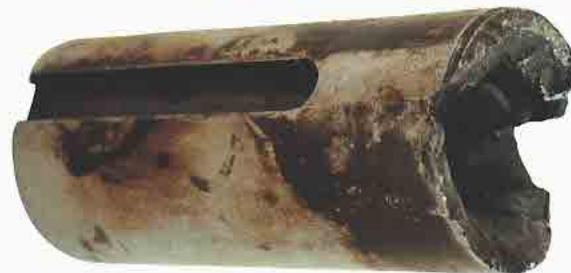
II-3-5-4 - Side plates deforma-
tions = contact on the smallest
diameter of the rotor.

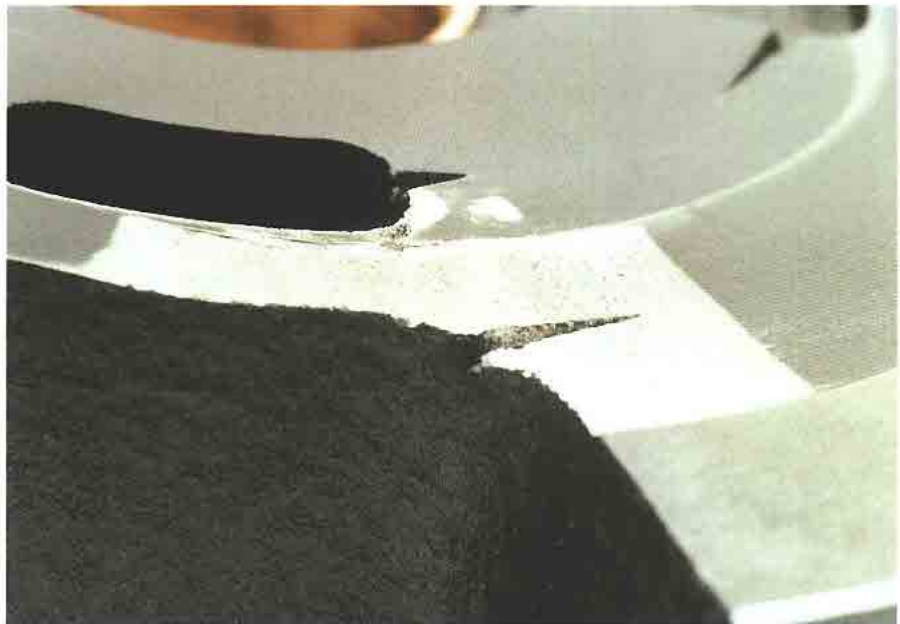
II-4-2-2-1 - If the quantity of air is erratic or not too heavy, the effects are scores only on the port plates in the suction area

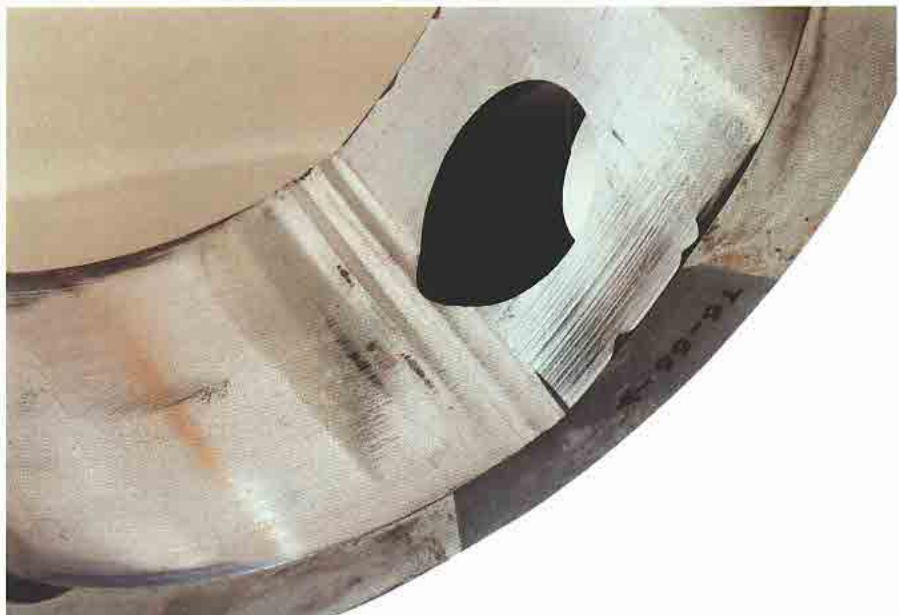
II-4-2-2-4 - Noisy

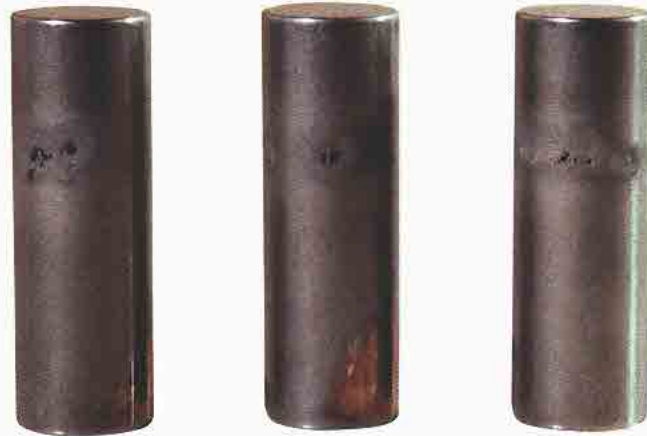
- pins

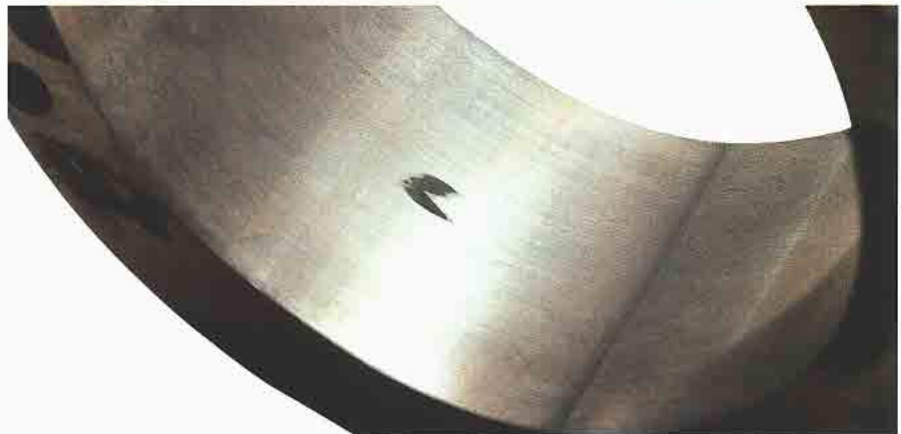
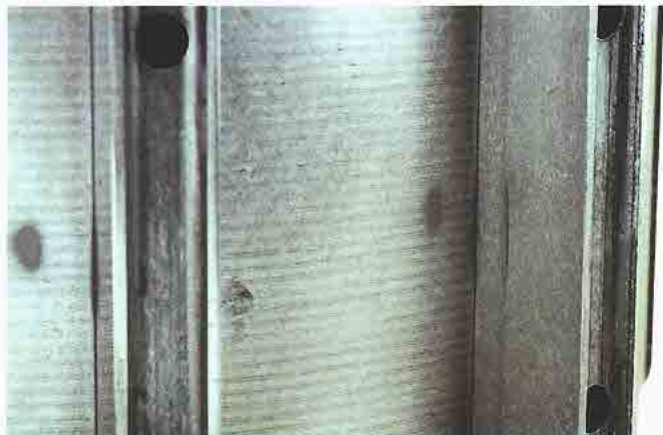
II-4-2-4-4 - "Black marks":

The local depression consequences can be seen on the vanes (top lips and on the center of the vane), on the port plates (in the inlet area) and on the center of the cam ring (just after the inlet "feeding hole"). These "black marks" can be transformed into small craters in the port plates near the outlet bleed slots as the air bubbles explosion occurs.

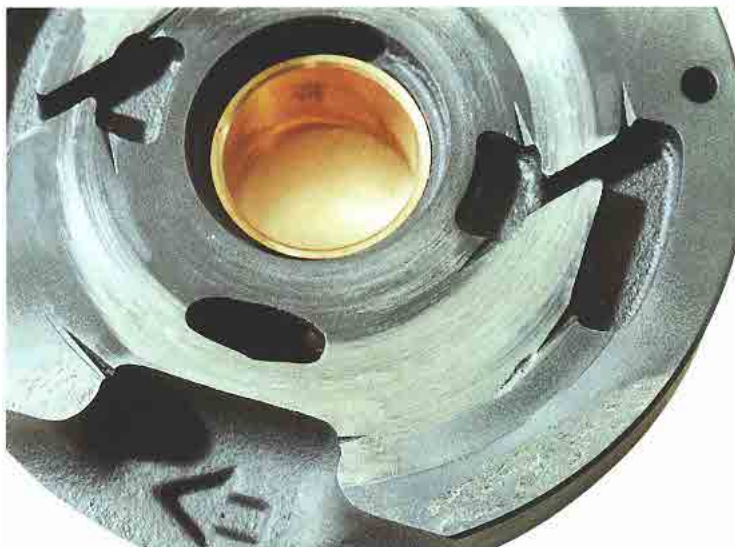
II-4-4-4 - Rotor/side plates:

When the particles in suspension in the fluid are greater than half of the clearance between the thickness of the rotor and the thickness of the cam ring, seizure occurs in the peripheral diameter of the rotor and the port plates.

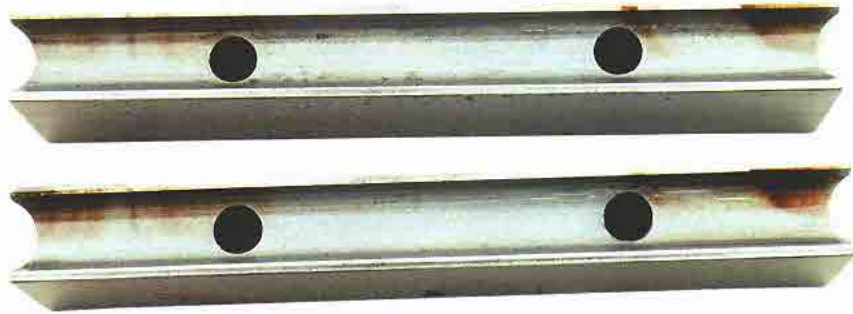
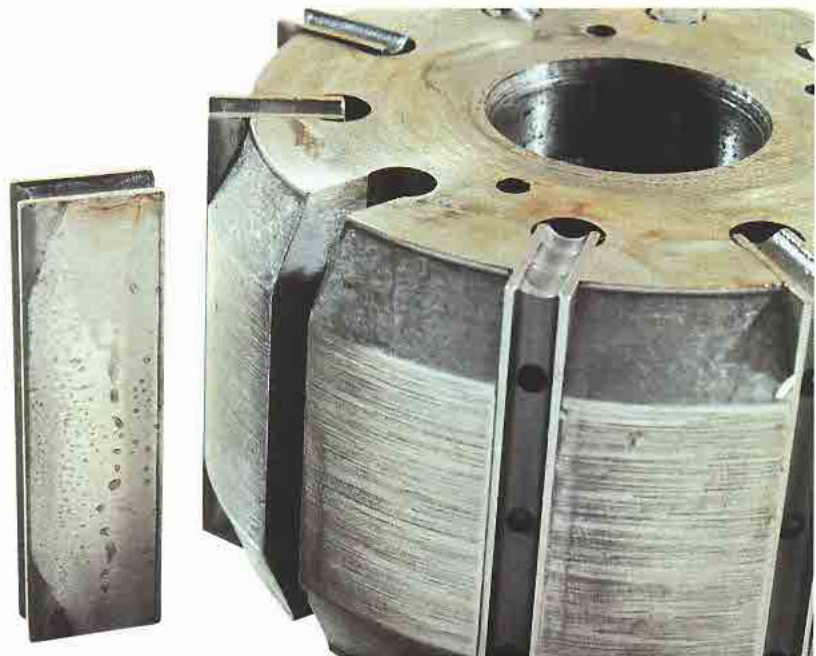
On the cartridge, it changes the colour of the bronze bushing (due to the modification of the acidity) and leaves a deposit on the external diameter.

II-4-6-2 - The fluid can produce foaming because of the steam. The specificity of the foaming oil due to water is a milky or creamy typical aspect. The consequences are identical to the aerated fluid.
